New York State Department of Transportation

Yellow Flag NB23U4W020

BIN: 1065318

Feature Carried: 278I278IX2M23027

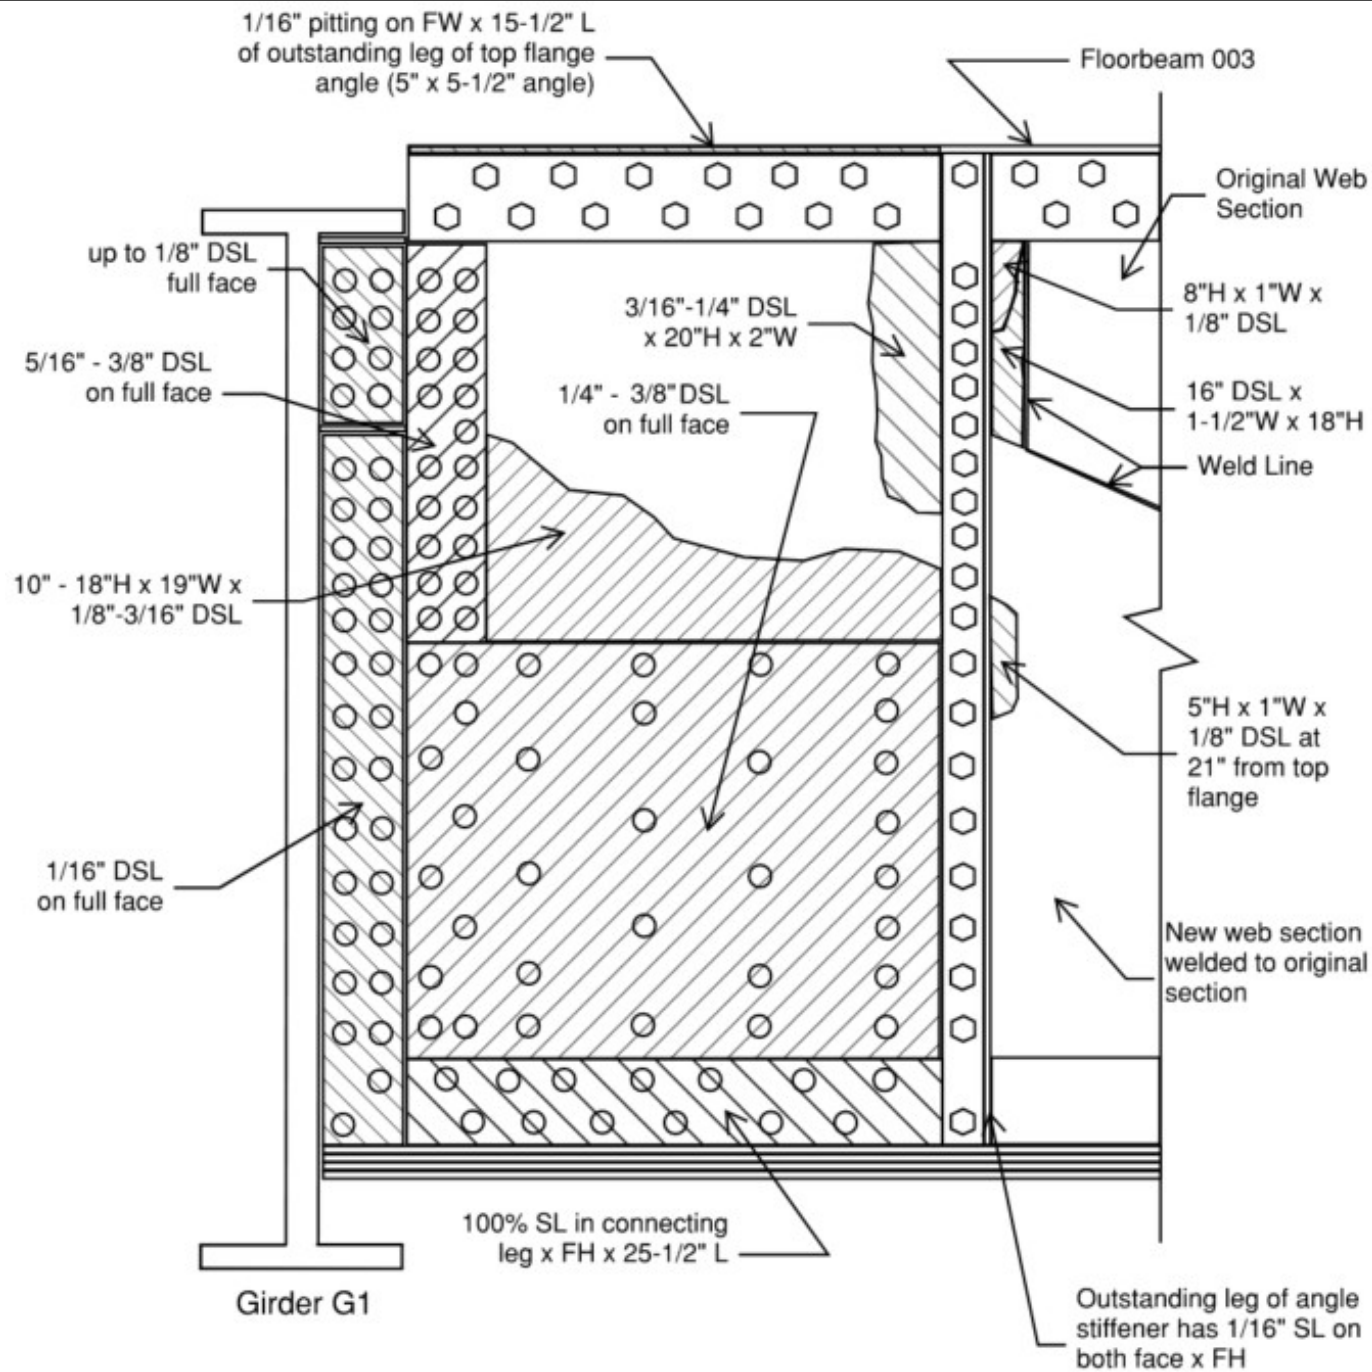
Photo Number: 2

- For Floorbeam FB-3 Begin Face (Refer to sketch 1- Photo 2, Photo 7 and Photo 8):

Floorbeam FB-3 begin face has 2 connection angles (short angle on top and long connection angle at the bottom) in the connection to the Girder G1 right face:

1. Short connection angle located above exhibits up to 1/8" section loss (approx. 17% section loss) on full face of both legs.
2. Long connection angle located below short angle, exhibits 1/16" section loss (approx. 8% section loss) on full face of both legs.

Floorbeam FB-3 begin face has built-up top and bottom flanges with 5" x 5-1/2" angle sections:

1. Top Flange angle has 1/16" pitting (approx. 8% section loss) for Full Width x 25-1/2" L in outstanding leg.
2. Bottom Flange angle exhibits 100% section loss in connecting vertical leg for FH x 25-1/2" L.

Floorbeam FB-3 begin face has built-up web with web center plates and 2 pieces of web cover plates on top:

1. Web upper cover plate exhibits 5/16" – 3/8" section loss (approx. 55% to 66% section loss) on Full Face (as-inspected original dimension – 32" H x 6-3/4" W x 9/16" thick).
2. Web lower cover plate exhibits section loss varying from 1/4" to 3/8" (approx. 44% to 66%) on Full Face (as-inspected original dimension – 38" H x 25-1/2" W x 9/16" thick).
3. Web center plate exhibits 1/8" – 3/16" section loss (approx. 31% to 47%) (10"-18" H x 19" W) located above the Web Lower Cover Plate. There is a 3/16" – 1/4" section loss (approx. 47% to 63%) (20"H x 2"W) below top flange angle in upper web, adjacent to intermediate stiffener angle. (as-measured web thickness per d-meter reading - 0.40" thick).

3. Floorbeam FB3 web has a portion of the original section and a portion of a "newer" web section (as part of a past bridge rehabilitation) welded to each other with a vertical weld line and then an inclined weld line (see photo 2, sketch 1).

- There is 1/8" section loss (8"H x 1"W) and up to 1/16" section loss (1-1/2"W x 18"H) adjacent to vertical weld line in the original web section.
- There is 1/8" section loss in the "newer" web section (located at 21" from the top flange) in area of 5"H x 1"W.

SPAN 300, FLOORBEAM 003 AT GIRDER G1 RIGHT SIDE
(LOOKING END)
N.T.S

Attachment Description: Flag Condition Sketch 1

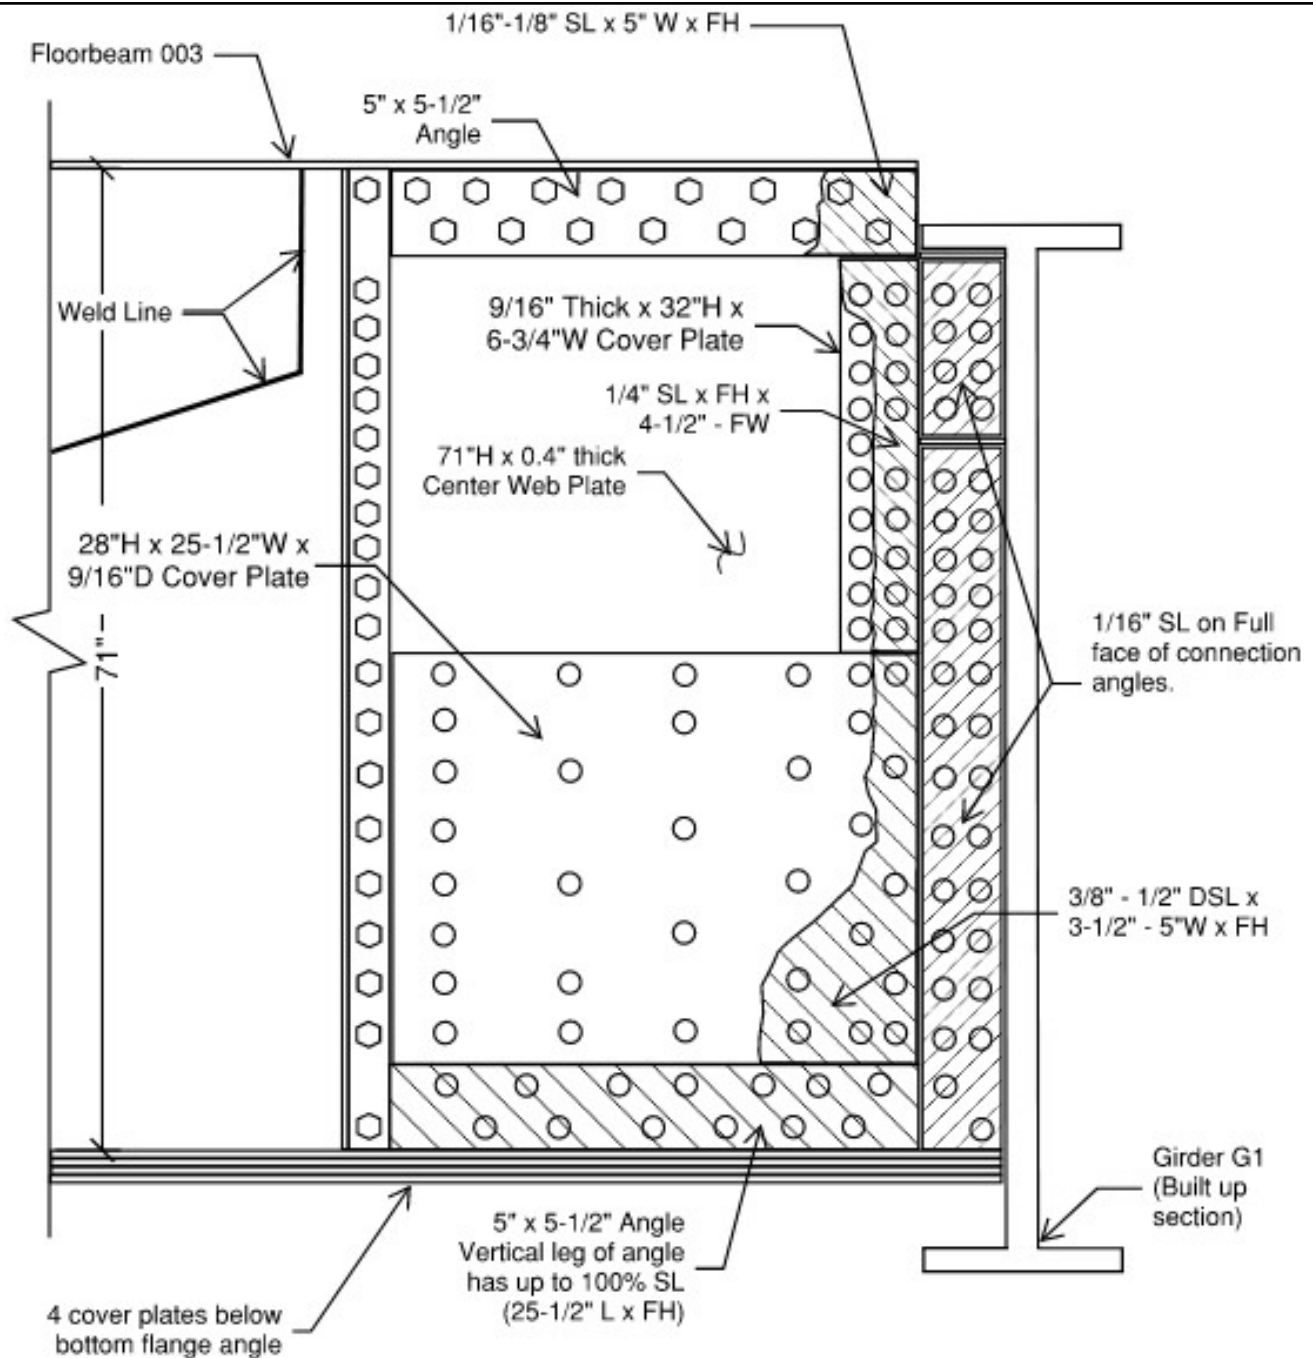
Photo Number: 3

- For Floorbeam FB-3 End Face (Refer to sketch 2- Photo 3, Photo 9 and Photo 10):

Floorbeam FB-3 end face has 2 connection angles (short angle on top and long connection angle at the bottom) at the connection to the Girder G1 right face.

1. Both angles exhibit 1/16" section loss (approx. 8% section loss) on full face.

Floorbeam FB-3 end face has built-up top and bottom flanges with 5" x 5-1/2" angle sections:

1. Top Flange angle has 1/16 – 1/8" section loss (approx. 8% to 17% section loss) for Full Height x 5" L in connecting leg.
2. Bottom Flange angle exhibits up to 100% section loss in connecting vertical leg for FH x 25-1/2" L.

- Floorbeam FB-3 end face has built-up web with web center plates and 2 pieces of web cover plates on top:

1. Web upper cover plate exhibits 1/4" section loss on Full Height x 4-1/2" W to FW (approx. 44%) (as-inspected original dimension – 32" H x 6-3/4" W x 9/16" thick).
2. Web lower cover plate exhibits section loss varying from 3/8" – 1/2" on Full Height x 3-1/2" to 5" W (approx. 66% to 88%) (as-inspected original dimension – 38" H x 25-1/2" W x 9/16" thick).
3. Web center plate has no significant section losses visible on end face.

SPAN 300, FLOORBEAM 003 AT GIRDER G1 RIGHT SIDE
(LOOKING BEGIN)
N.T.S

Attachment Description: Flag Condition Sketch 2

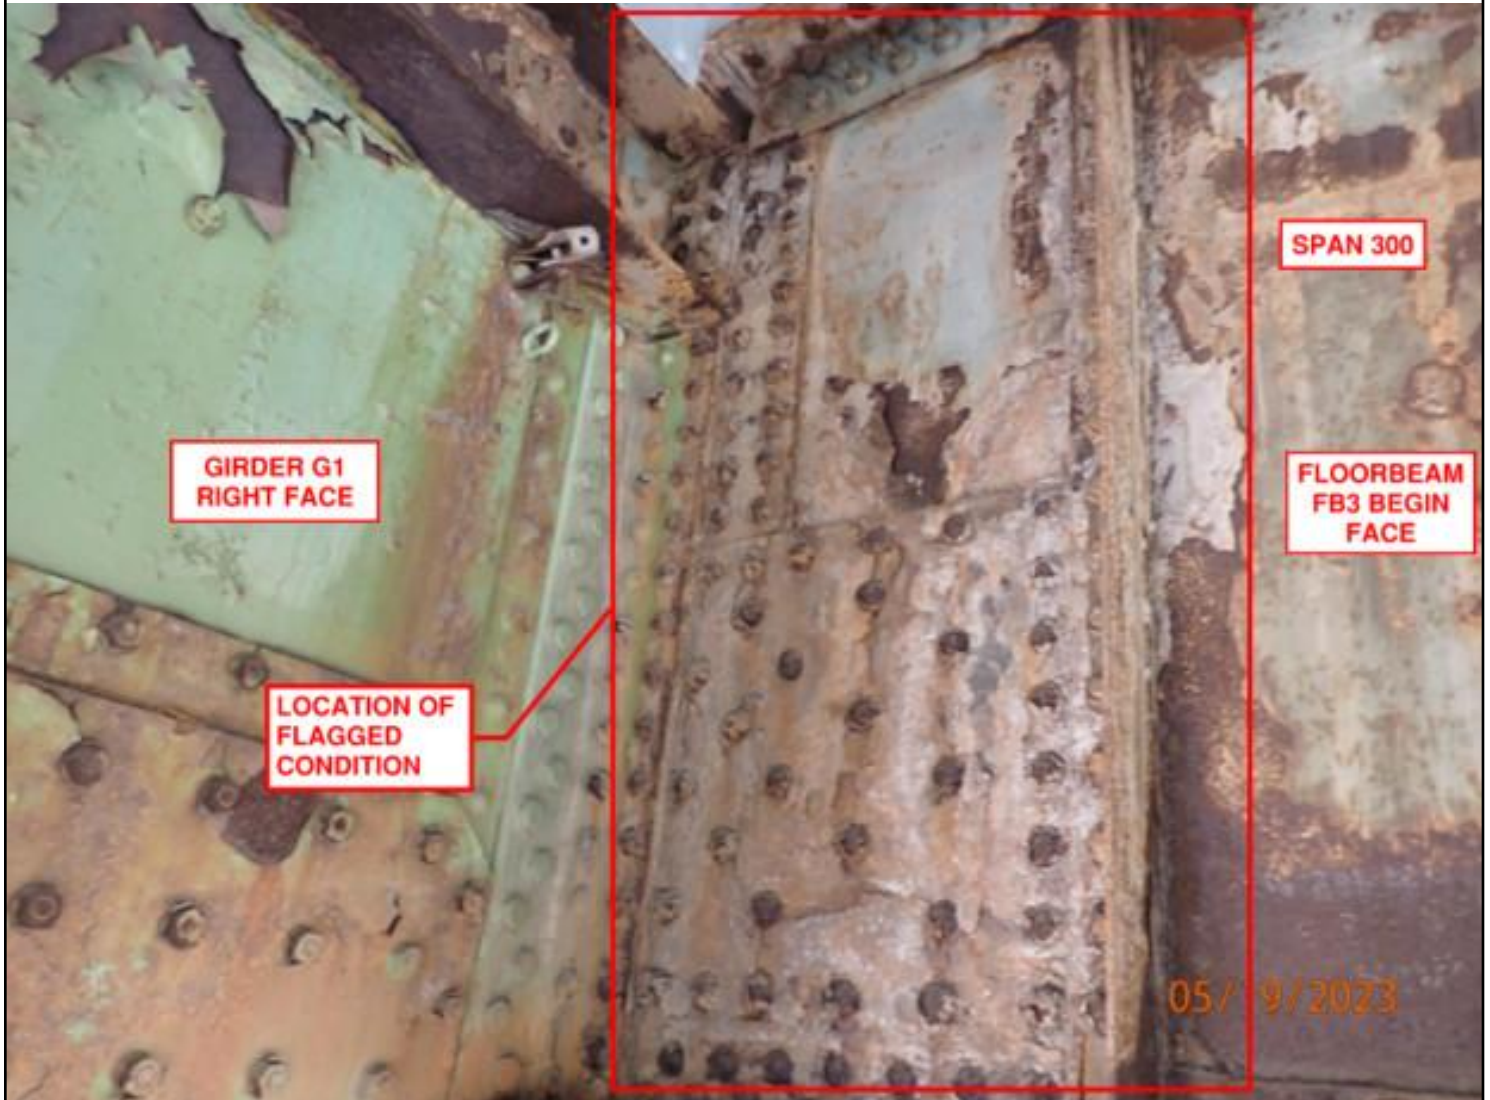
Photo Number: 4

Attachment Description: General View of Flag Condition on Floorbeam FB3 Begin Face before removal of delaminated steel. Looking End.

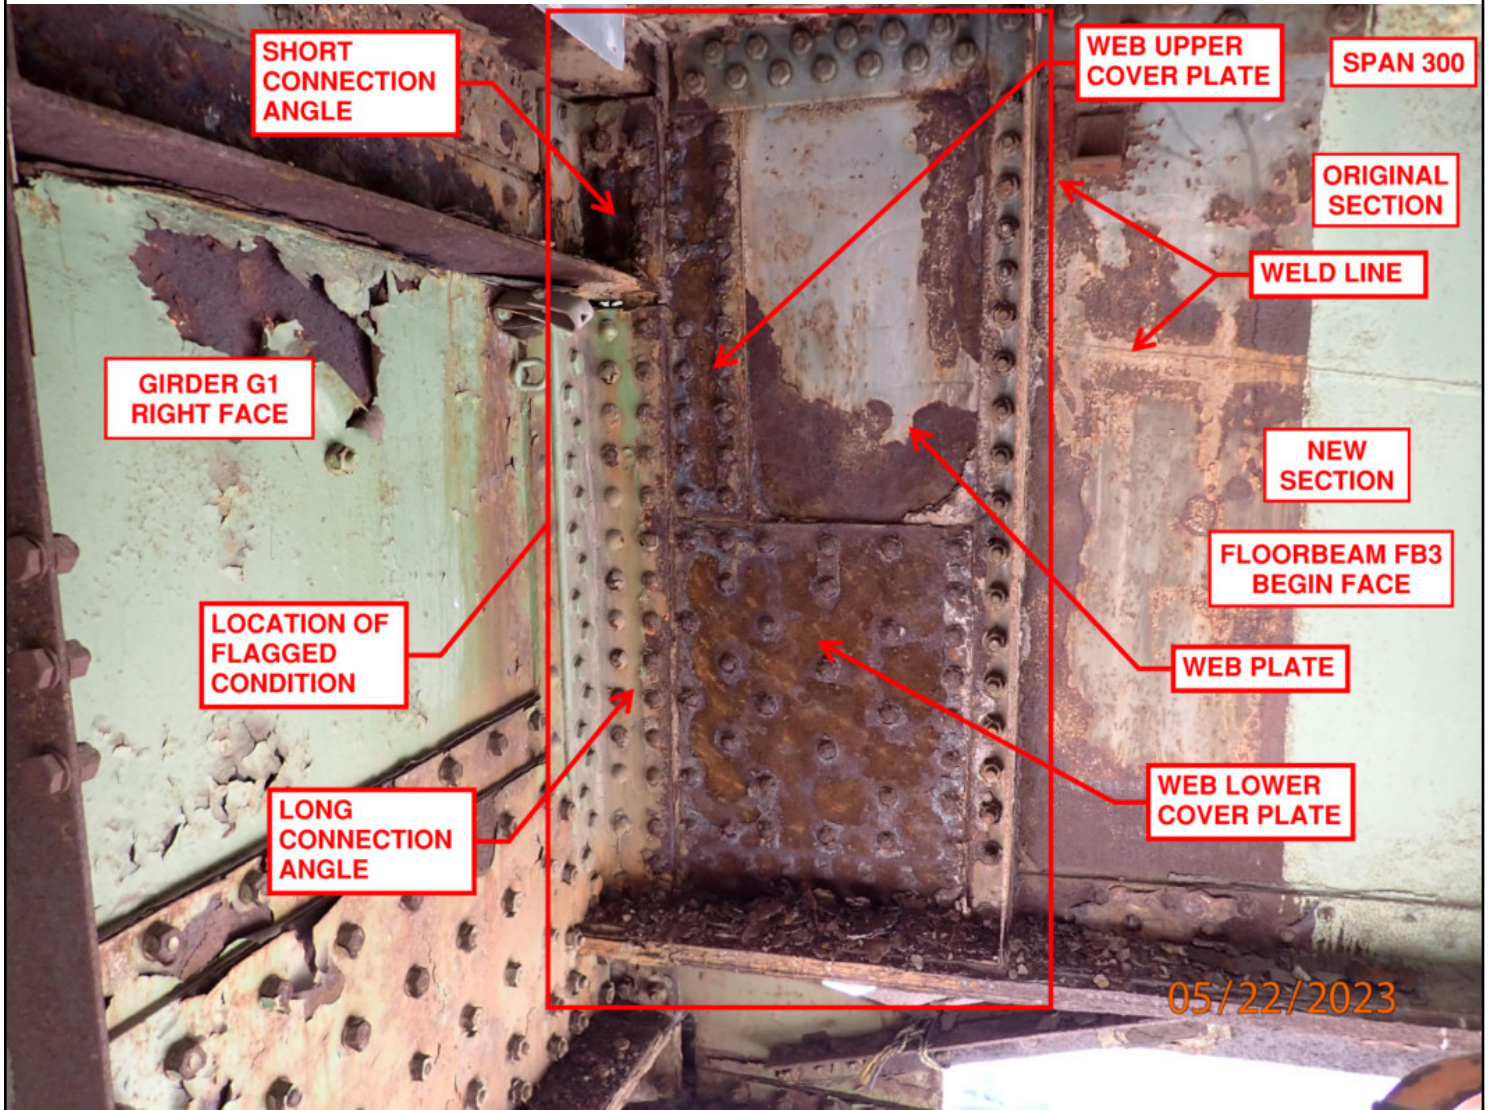
Photo Number: 5

Attachment Description: General View of Flag Condition on Floorbeam FB3 Begin Face after removal of delaminated steel. Looking End.

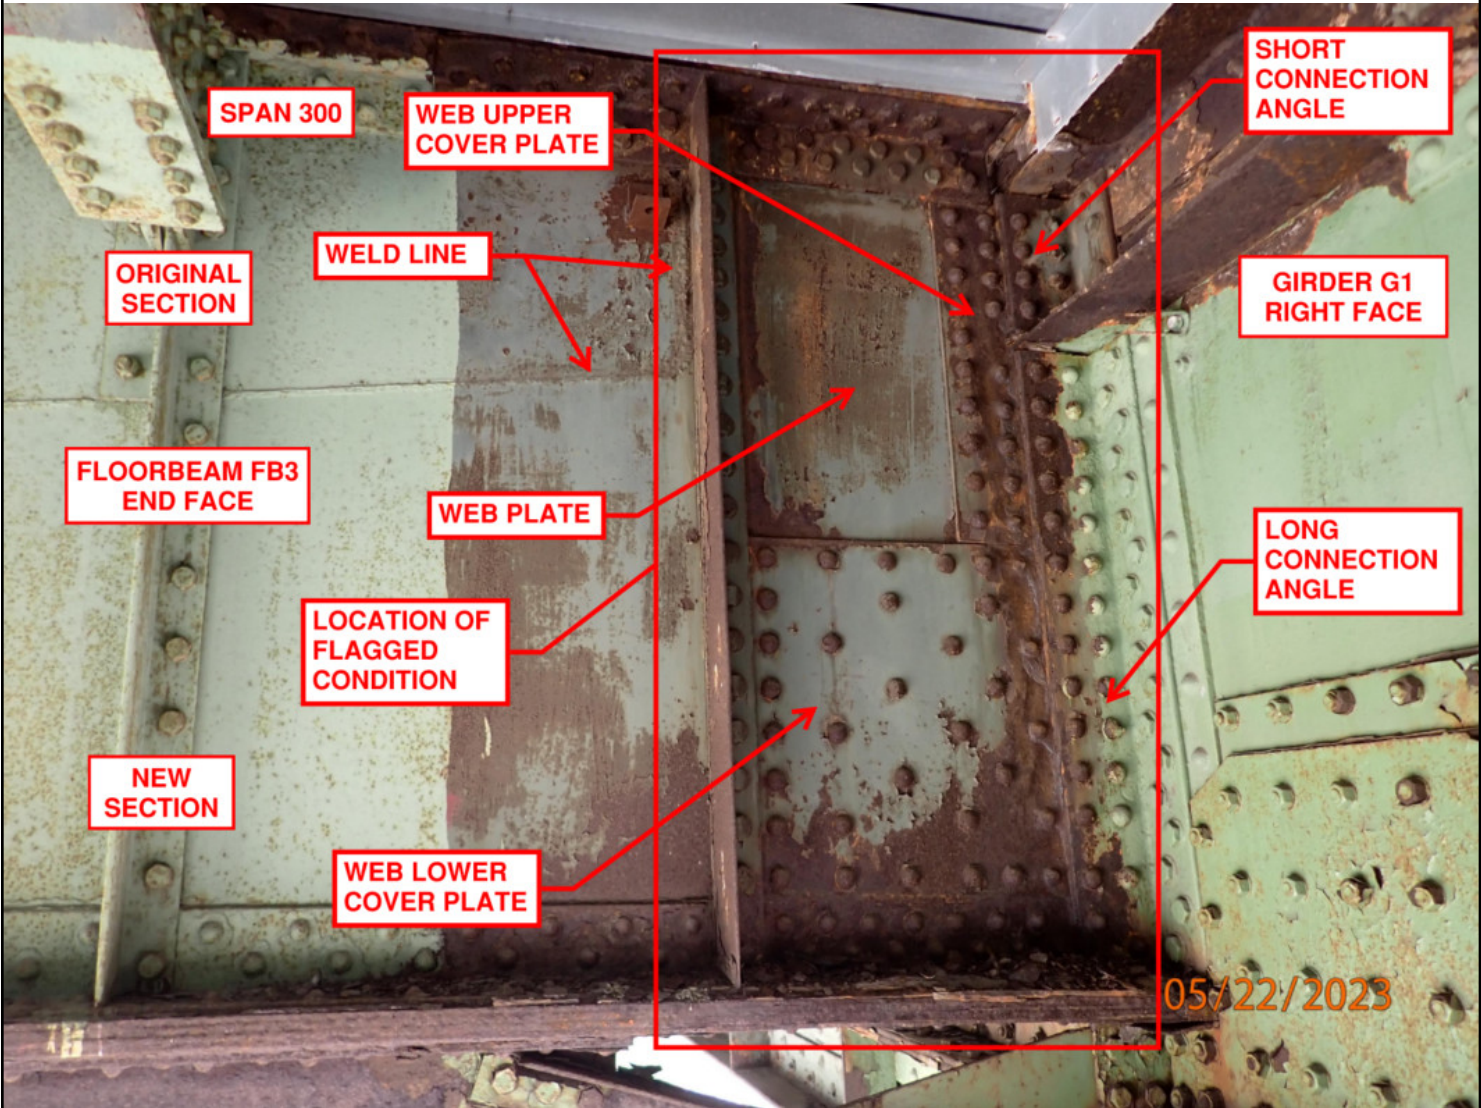
Photo Number: 6

Attachment Description: General View of Flag Condition on Floorbeam FB3 End Face. Looking Begin.

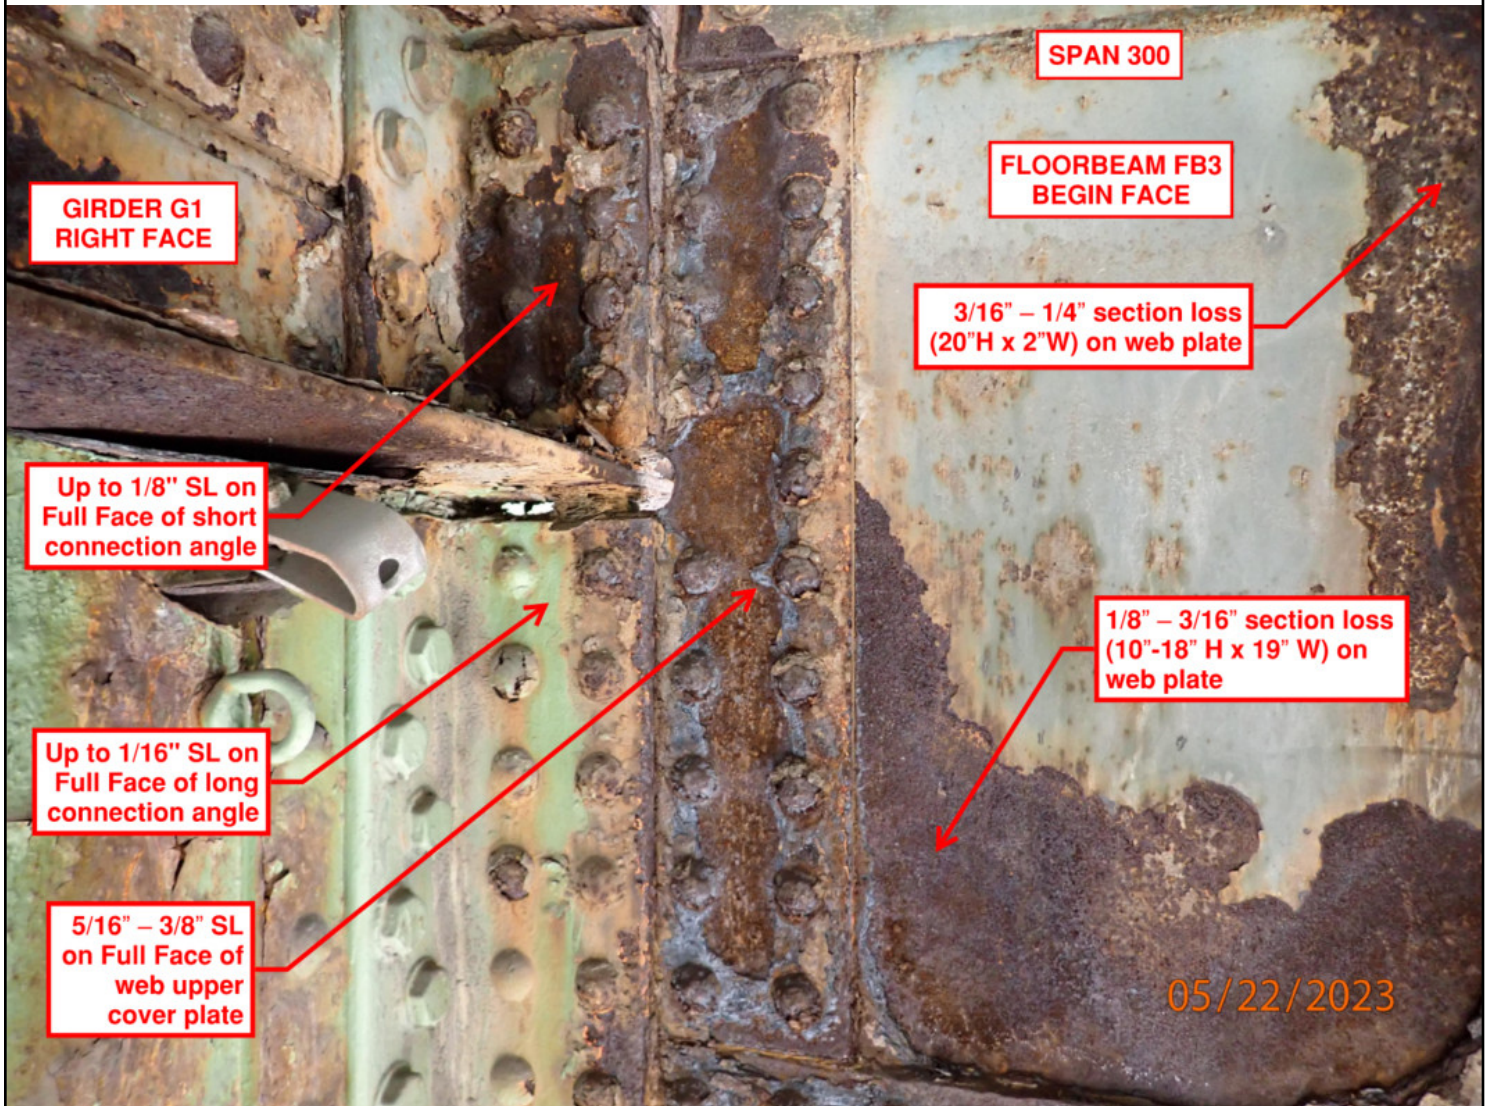
Photo Number: 7

Attachment Description: Web upper cover plate has 5/16" – 3/8" SL on Full Face, web center plate has 1/8" – 3/16" SL (10"-18" H x 19" W) and, a 3/16" – 1/4" SL (20"H x 2"W). Short connection angle located above has up to 1/8" section loss and long connection angle located below short angle, has 1/16" section loss on full face of both legs. Looking End.

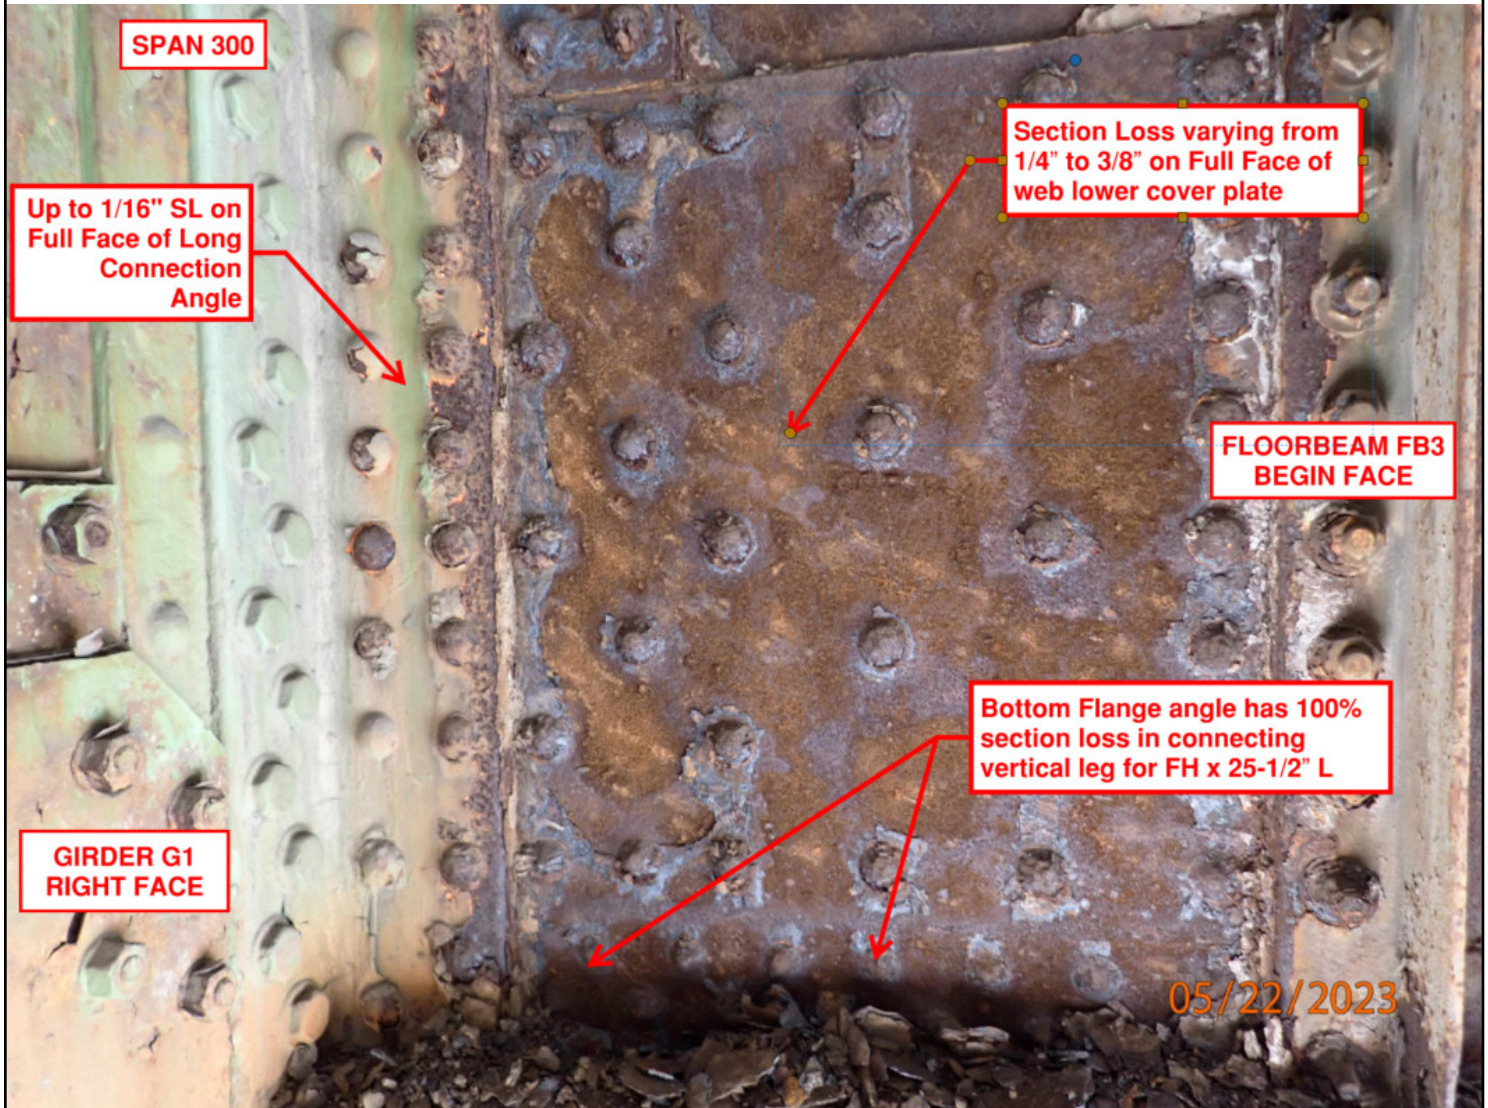
Photo Number: 8

Attachment Description: Web lower cover plate exhibits section loss varying from 1/4" to 3/8" on Full Face. Bottom Flange angle exhibits 100% section loss in connecting vertical leg for FH x 25-1/2" L. Looking End.

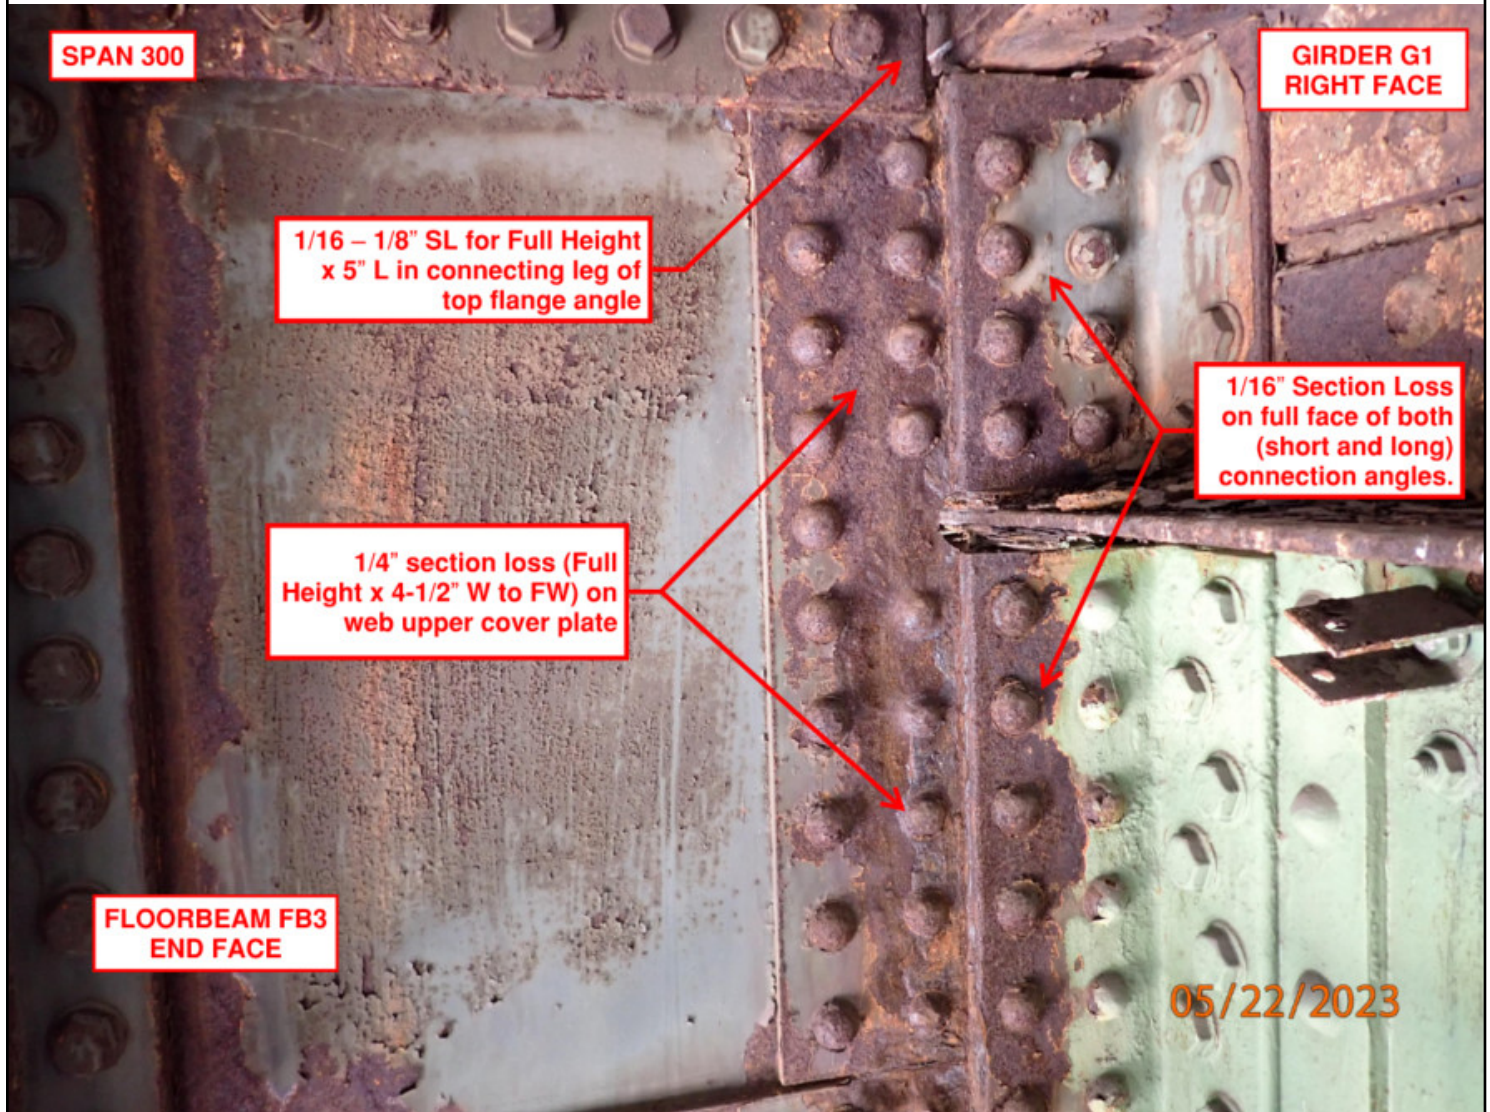
Photo Number: 9

Attachment Description: Both connection angles exhibit 1/16" section loss on full face. Top Flange angle has 1/16 – 1/8" section loss for Full Height x 5" L in connecting leg. Web upper cover plate exhibits 1/4" section loss on Full Height x 4-1/2" W to FW. Looking Begin.

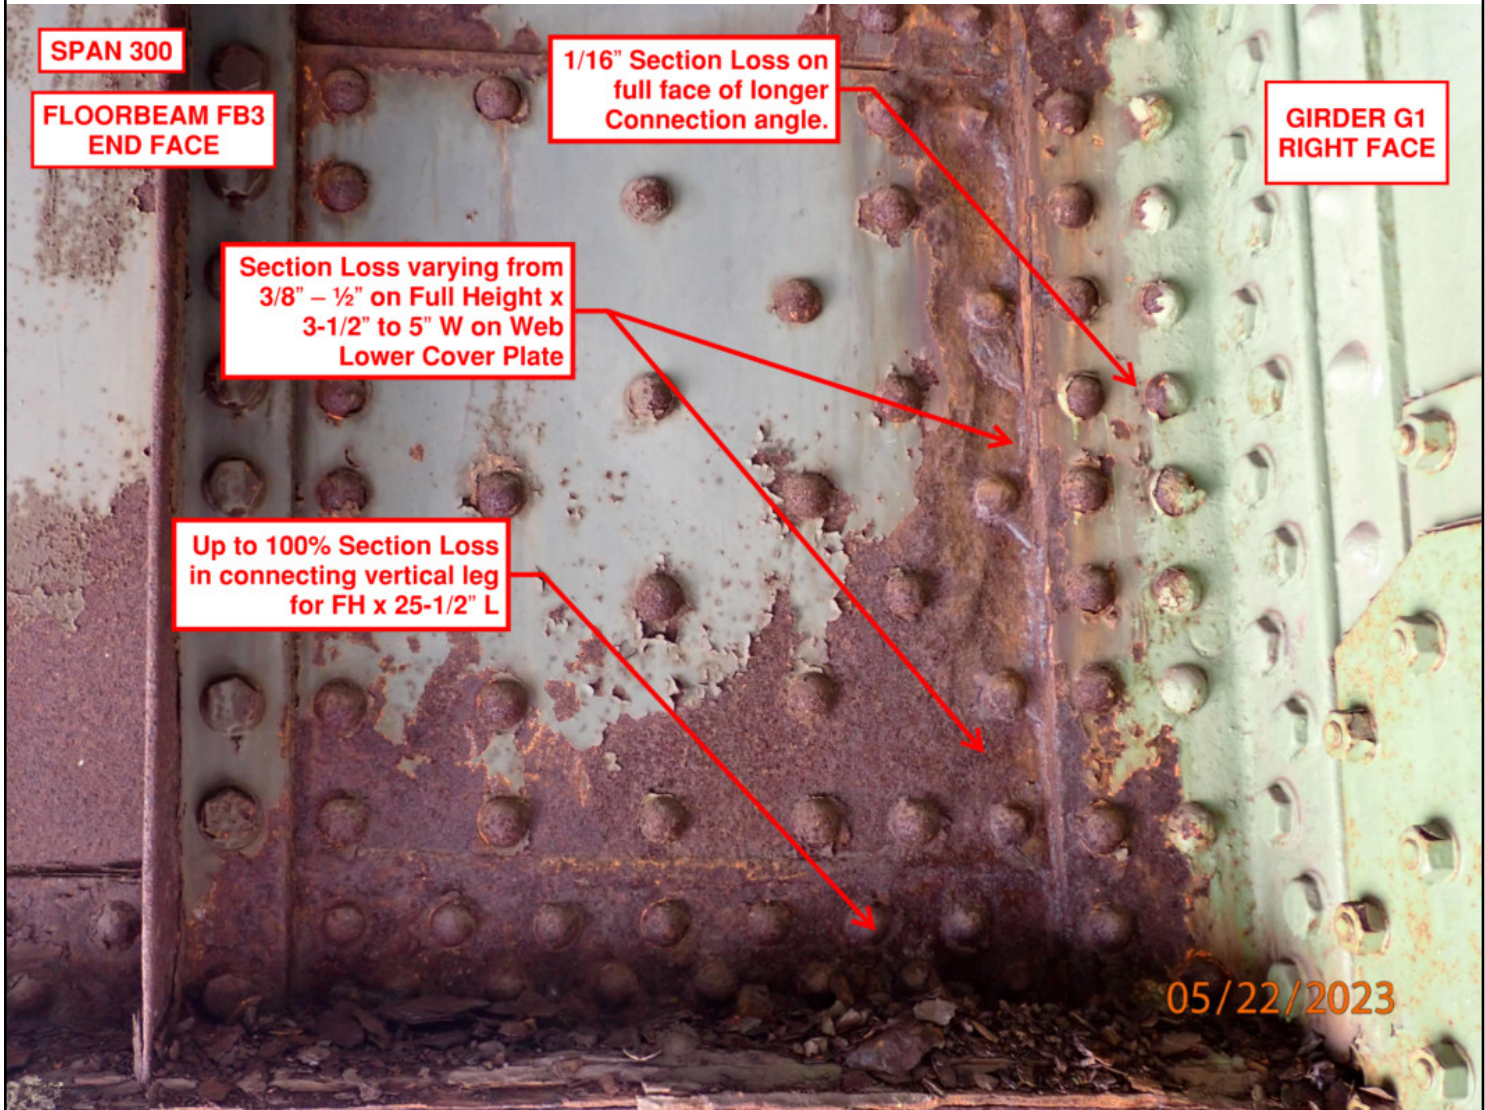
Photo Number: 10

Attachment Description: Lower connection angle exhibits 1/16" section loss on full face. Bottom Flange angle exhibits up to 100% section loss in connecting vertical leg for FH x 25-1/2" L. Web lower cover plate exhibits section loss varying from 3/8" – 1/2" on Full Height x 3-1/2" to 5" W. Looking Begin.
